50PG20 INTERCONNECT DIAGRAM

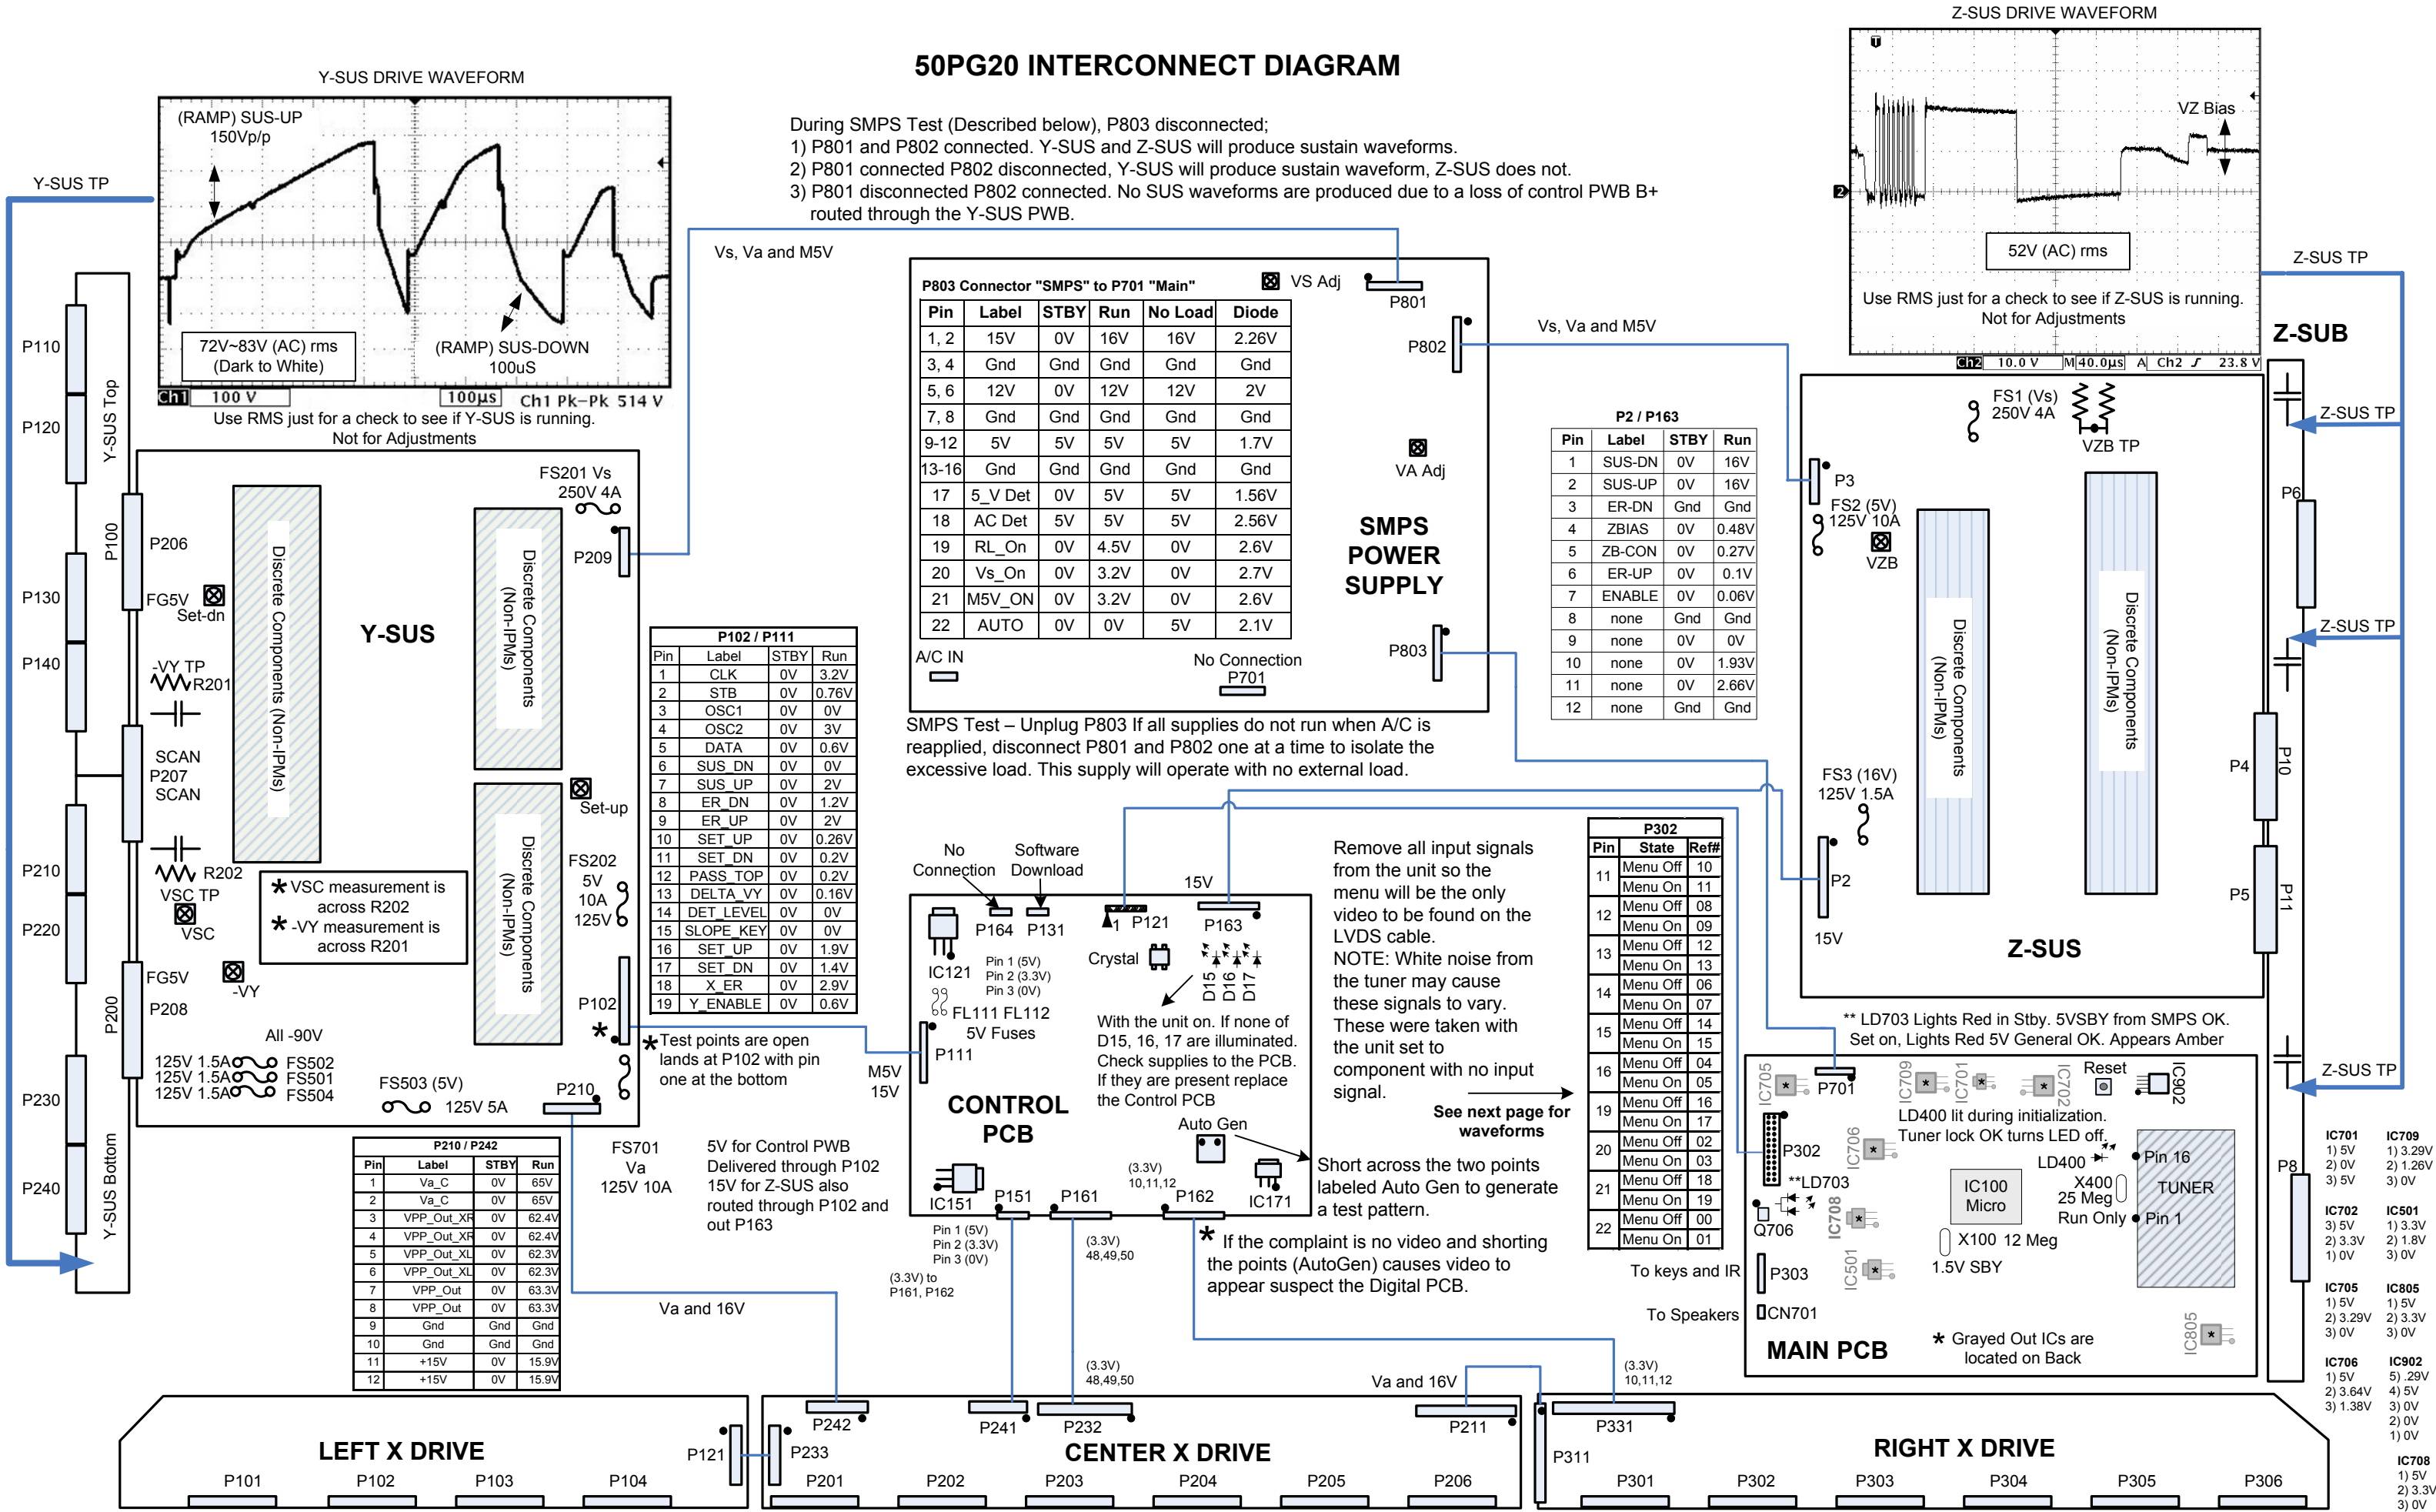
During SMPS Test (Described below), P803 disconnected;
1) P801 and P802 connected. Y-SUS and Z-SUS will produce sustain waveforms.
2) P801 connected P802 disconnected, Y-SUS will produce sustain waveform, Z-SUS does not.
3) P801 disconnected P802 connected. No SUS waveforms are produced due to a loss of control PWB B+ routed through the Y-SUS PWB.

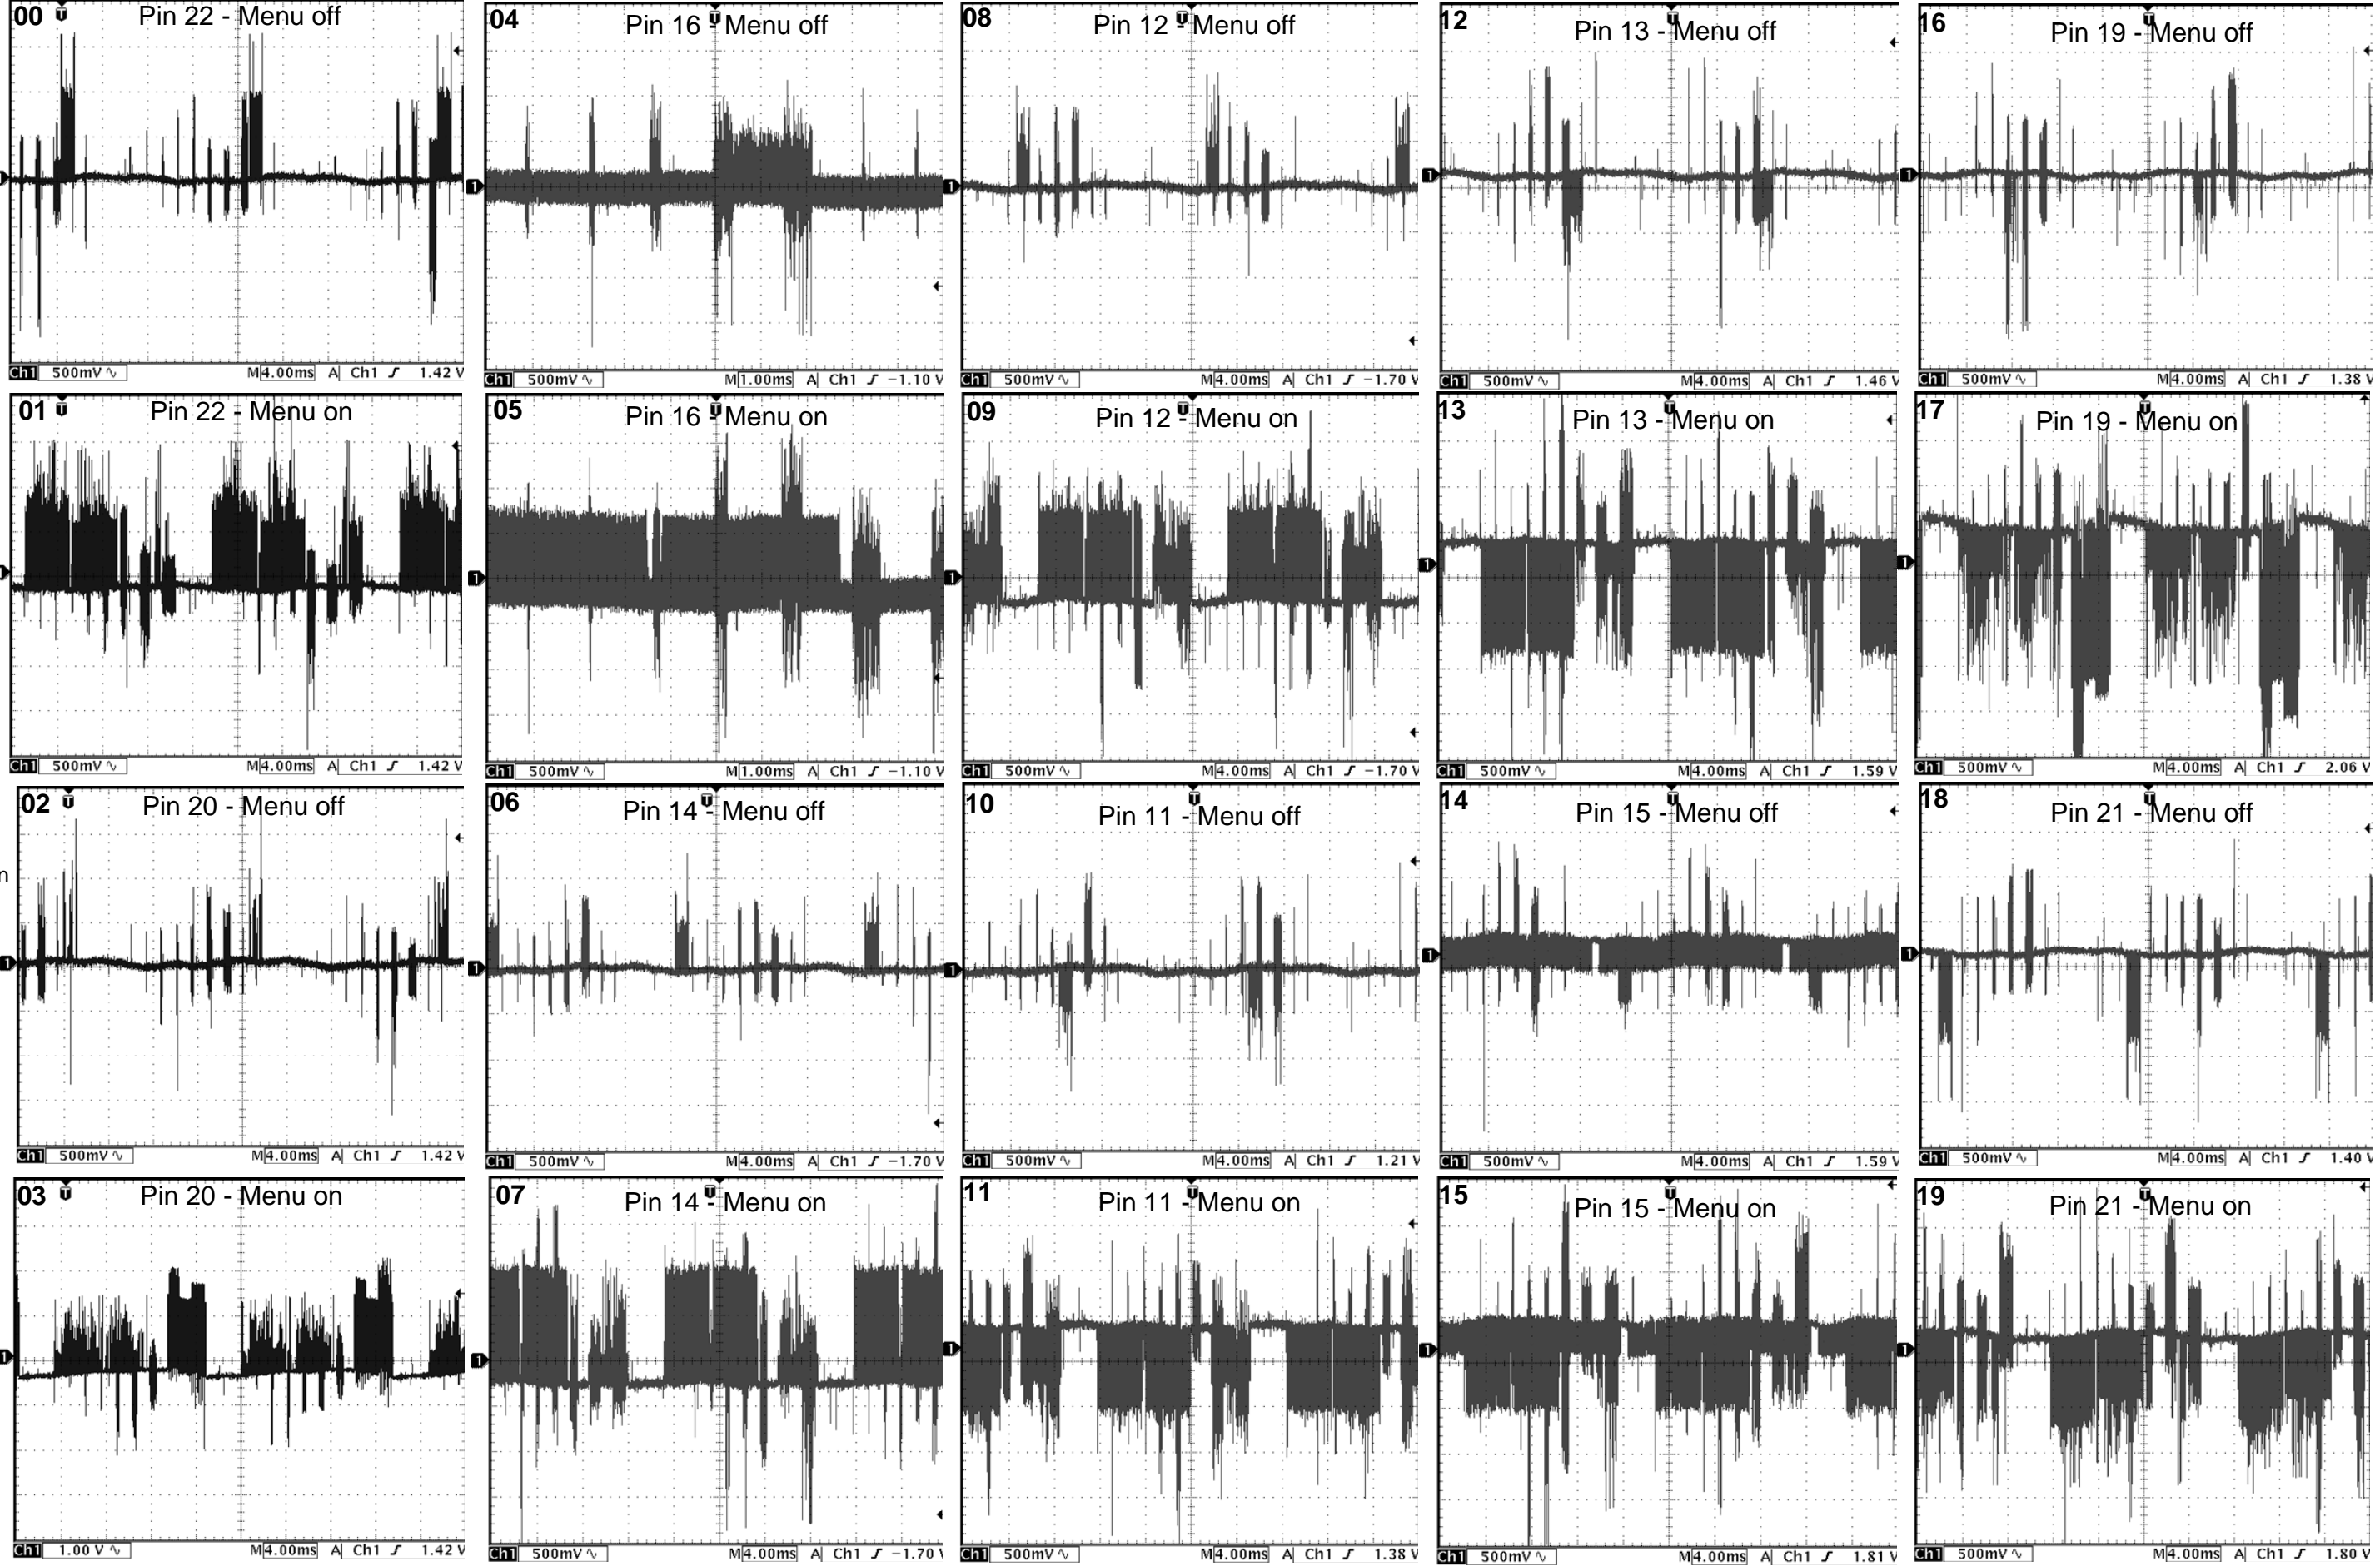
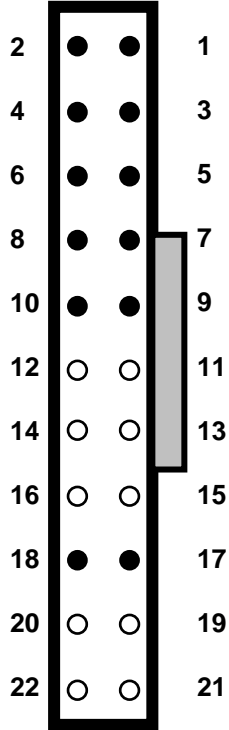
Connector P302 Configuration
○ - indicates signal pins.

P302		
Pin	State	Ref #
11	Menu Off	10
	Menu On	11
12	Menu Off	08
	Menu On	09
13	Menu Off	12
	Menu On	13
14	Menu Off	06
	Menu On	07
15	Menu Off	14
	Menu On	15
16	Menu Off	04
	Menu On	05
19	Menu Off	16
	Menu On	17
20	Menu Off	02
	Menu On	03
21	Menu Off	18
	Menu On	19
22	Menu Off	00
	Menu On	01
